# BORDER PATROL

## Procurement of MD 600N Helicopters Should Be Reassessed

GAO/GGD-00-201

September 29, 2000

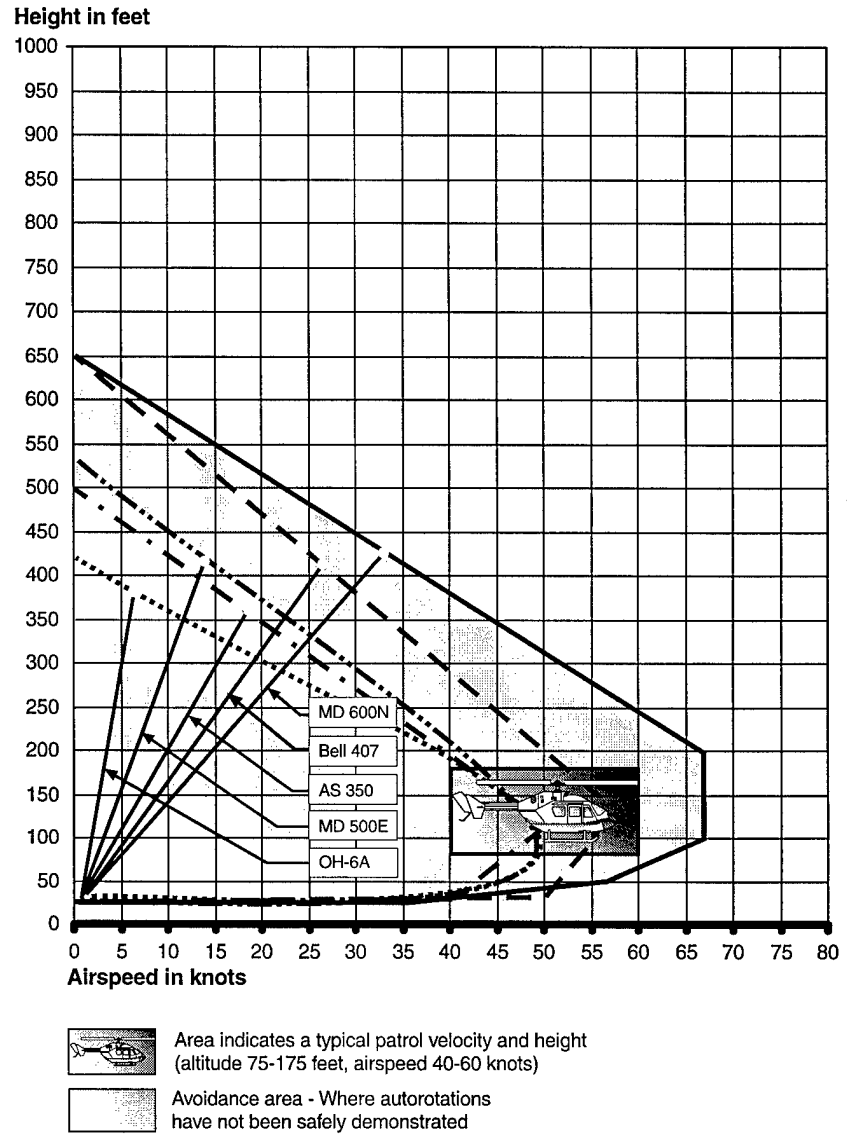
**Figure 3: Height/Velocity Curves for MD 500E, MD 600N, Bell 407, American Eurocopter AS 350, and Hughes OH-6A**

Most of the pilots we interviewed believed that the autorotation characteristics of the MD 600N are inappropriate for much of the flying performed during Border Patrol air operations missions. Autorotation is a pilot-recovery maneuver performed in the event of an engine failure that keeps the main rotor blades moving so that the aircraft descent can be controlled. Aircraft height and airspeed factors to be avoided during autorotation are depicted as a height/velocity curve.<sup>8</sup> Pilots are instructed

MDH officials stated that the pilots based their concerns on a misunderstanding of the height/velocity curve rather than on the helicopter's operational characteristics. According to MDH, the MD 600N's height/velocity curve appears to cover more area because of more stringent testing conditions used for establishing the curve.<sup>9</sup> However, we examined the height/velocity curves for several helicopters that were tested at or estimated for sea level. The MD 600N height/velocity curve had a larger area to avoid (see fig. 3). A senior FAA certification official said that this is a valid means for showing how different aircraft height/velocity curves relate to the height and airspeed of a typical Border Patrol mission.

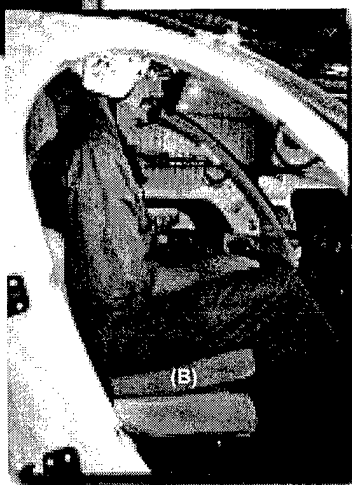
(B) Some pilots reported using seat cushions provided by Air Operations headquarters or their own cushions to relieve some of the discomfort caused by the seats in the MD 600N.

Air Operations officials agreed that the seats in the MD 600N are uncomfortable. Pilots had said they wanted padded seats, so the officials said they asked for high-quality seats during the procurement.<sup>17</sup> Air Operations officials recently took action to replace the seats provided under the original procurement. Seats tested by Border Patrol pilots during the flight evaluations for the stability augmentation system have been ordered and are being manufactured, as of September 21, 2000, according to INS.

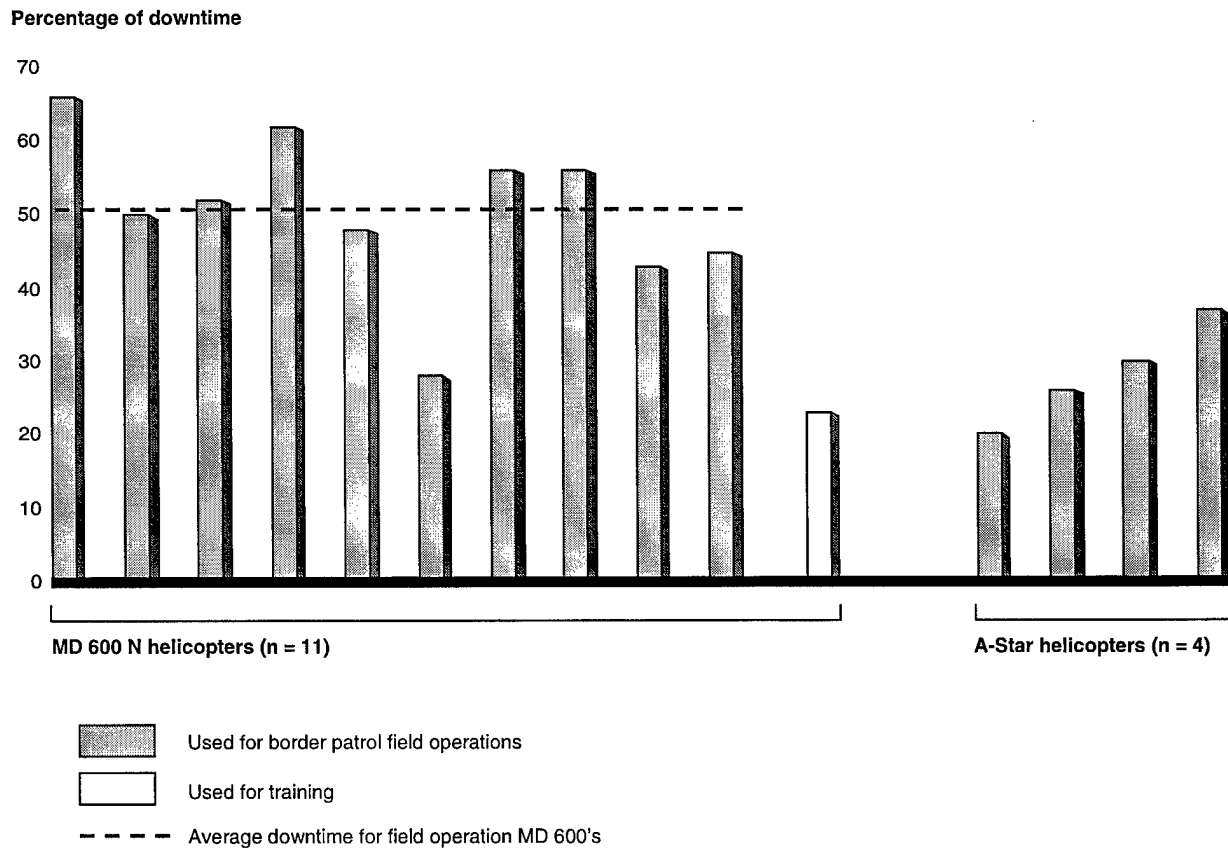
**Figure 5: Downtime for Border Patrol 600N Helicopters**

A major concern of most sector chiefs and their staffs was the significant amount of time in which the MD 600N helicopters were unavailable for use or "down." Air Operations records for December 1998 to March 2000 show that the 10 MD 600Ns assigned to Border Patrol field operations were unavailable, on average, over 50 percent of the time.<sup>18</sup> This downtime included any time that the helicopters were not operational due to avionics repair, maintenance, or while waiting for parts. In comparison, the four Border Patrol Eurocopter "A-Star" helicopters were down 28 percent of the time during the same period. Reasons for the downtime included delays in obtaining an engine repair contract, slow manufacturer approval for modifications, and parts availability.

An Air Operations official said that specific helicopters may have had problems that explained why they were inoperable. The official stated that, for example, two MD 600Ns were down due to foreign object damage to

the engines. The damage was discovered in November 1999, but the helicopters were not returned to service until March and April 2000, respectively, because Air Operations was without an engine repair contract from October 1999 to June 2000. Emergency engine repairs were requested in late November but not authorized until mid-February 2000.

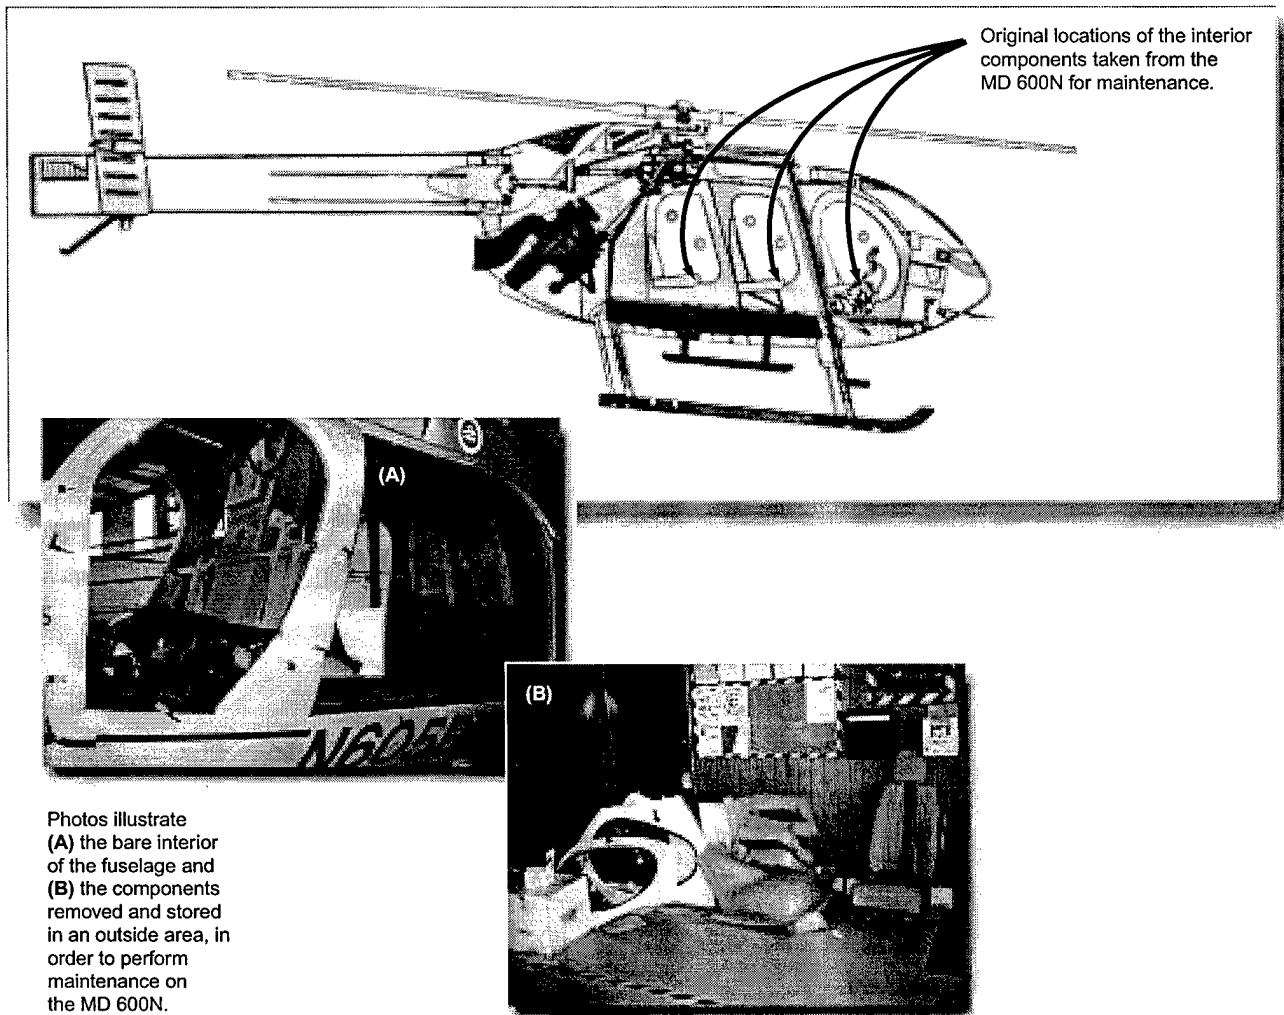
**Figure 6: Aircraft Repairs Often Require Interior to Be Removed**

Finally, mechanics in two sectors said that the design of the helicopter makes working on it time consuming because many repairs require that the aircraft be taken apart. One mechanic stated, for example, that often carpet must be pulled up, seats removed, and the interior vinyl removed in order for mechanics to access the aircraft's parts for a 100-hour inspection. Helicopters by other manufacturers, such as Bell, have their transmissions and drive trains located externally and would not need to have the interiors removed for a routine inspection, he said. The interiors have also experienced unusually high levels of wear and tear because of the need to remove them, one mechanic said.
